Main decommissioning work and steps

Fuel removal from the spent fuel pool was completed in December 2014 at Unit 4 and started from April 15, 2019 at Unit 3. Dust concentration in the surrounding environment is being monitored and work is being implemented with safety first. Work continues sequentially toward the start of fuel removal from Units 1 and 2 and debris (Note 1) retrieval from Units 1-3.

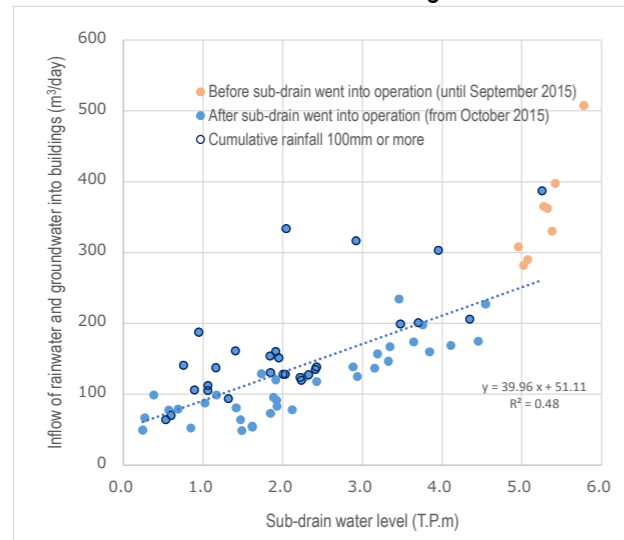
Figure 2: Correlation between inflow such as groundwater and rainwater into buildings and the water level of Units 1-4 sub-drains

- To maintain the groundwater level, work to install additional sub-drain pits and recover those existing is underway. The additional pits are scheduled to start operation sequentially, from pits for which work is completed (12 of 14 new sub-drain pits went into operation). To recover existing pits, work for all three pits scheduled was completed and all went into operation from December 26, 2018. Work to recover another pit (No. 49) started from November 2019 and it went into operation from October 9, 2020.
- To eliminate the need to suspend water pumping while cleaning the sub-drain transfer pipe, the pipe will be duplicated. Installation of the pipe and ancillary facilities was completed.
- Since the sub-drains went into operation, the inflow to buildings tended to decline to under 150 m³/day when the sub-drain water level declined below T.P. 3.0 m but increased during rainfall.

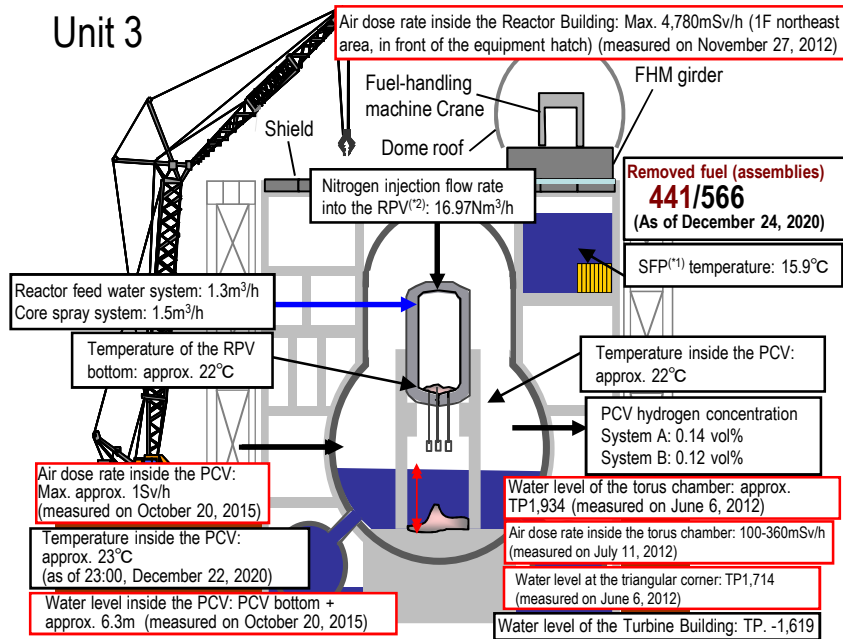
Investigative results into the Unit 3 PCV equipment hatch using a small investigation device

- As part of the investigation into the PCV to facilitate fuel debris retrieval, the status around the Unit 3 PCV equipment hatch was investigated using a small self-traveling investigation device on November 26, 2015.
- Given blots such as rust identified below the water level inside the PCV, there may be a leakage from the seal to the extent of bleeding. Methods to investigate and repair the parts, including other PCV penetrations with a similar structure, will be considered.
